# THE PAVEMENT QUALITY AND VIBRATIONS

SEBASTIAN TOPLAK<sup>1</sup>, SAMO LUBEJ<sup>1</sup>, ANDREJ IVANIČ<sup>1</sup> and MARJAN LEP<sup>1</sup>

<sup>1</sup>*Department of Transportation Eng., University of Maribor, Slovenia*

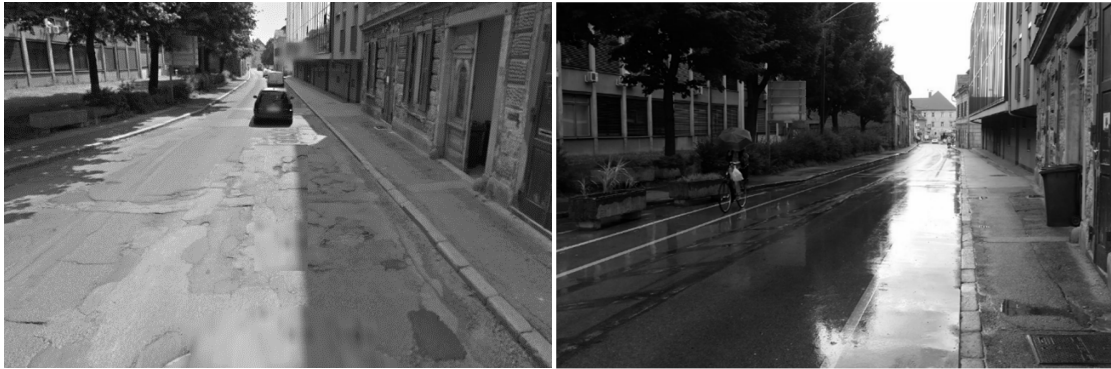
Figure 1. Old, damaged pavement (left) and new pavement (right).

In this paper we have focused on and analyzed one very common phenomenon which occurs when poor pavement is replaced during road reconstruction: with increased comfort for drivers, a lot of additional traffic is induced and the livability of the neighborhood worsens. We observed two different situations in the old city centre of Maribor, Slovenia (Figure 1):

- Old, damaged pavement.
- New pavement.

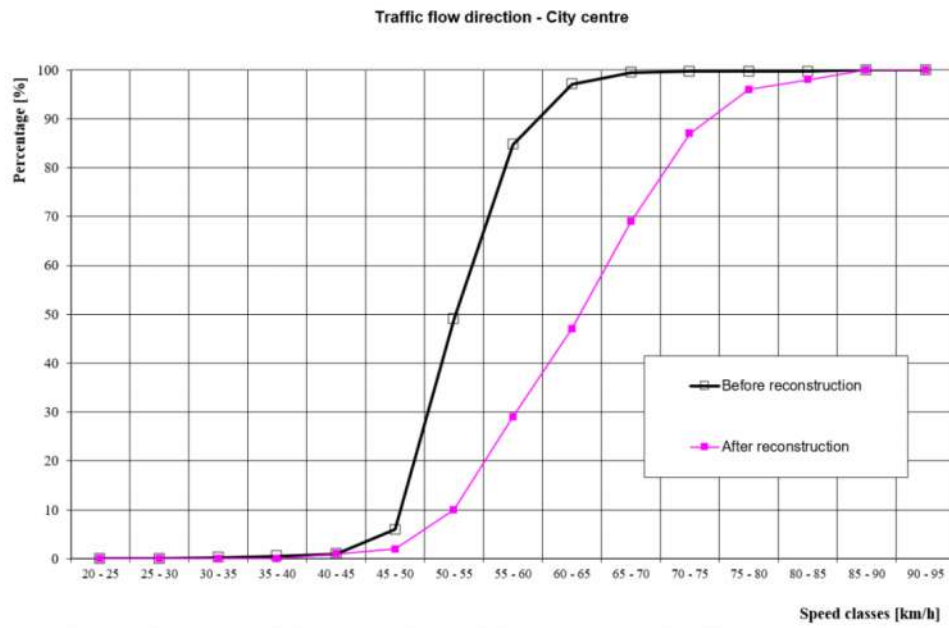
Figure 3. Cumulative speed distribution of free traffic flow into the City centre.

The values of the measured speeds before and after road reconstruction are very different. After the reconstruction the speed increases. V85 in the direction of the City Centre increased from 44.97 km/h to 62.78 km/h (Figure 3) and exiting the City Centre from 45.10 km/h to 59.44 km/h (Figure 4).

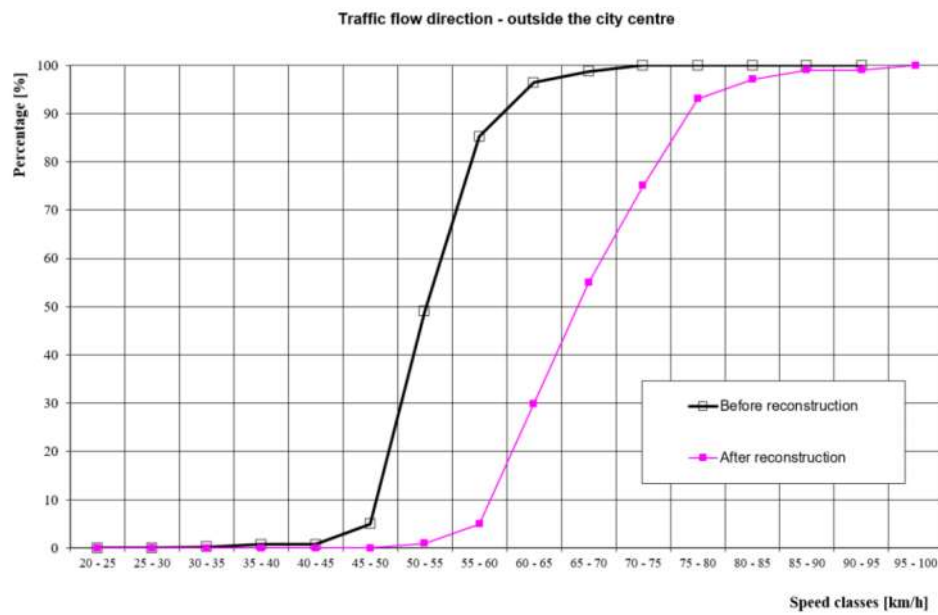
Figure 4. Cumulative speed distribution of free traffic flow out of the City centre.

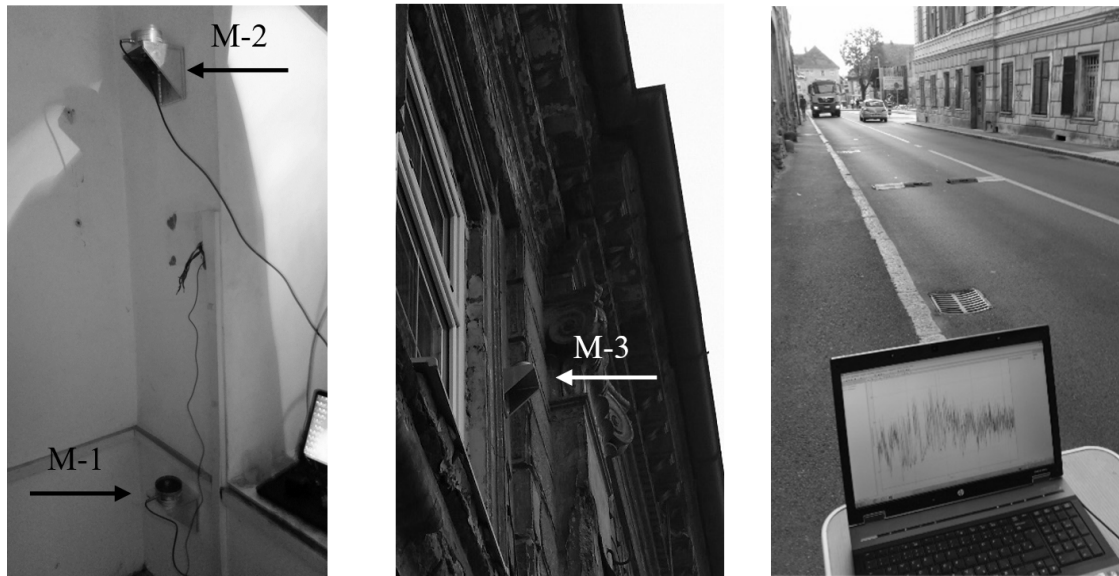
For the measurement of vibrations caused by traffic, we set three measurement points in the old building which is historically protected (Figure 5). The first one was placed inside the building on the wall at 0.5 m from the ground (M-1), the second one was also placed inside

the building on the wall at 2.0 m from the ground (M-2) and the third one was placed on the building wall outside at 6.4 m from the ground (M-3). The results of the measurement point M-1 are analyzed in Table 2.

Figure 5. The measurement points at the old building close to Koroska Street.

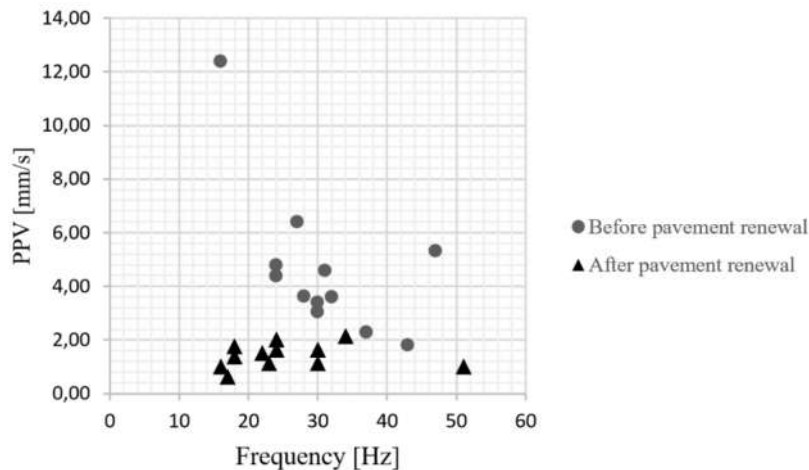
Results of vibration measurements before pavement renewal show (Figure 6) that the vibrations induced by urban buses and medium-duty vehicles are predominantly in the range from 16 to 47 Hz (oscillations per second) and have a peak vibration velocity (PVV) from

1.82 to 12.4 mm/s. Measurements of vibrations after pavement renewal (Figure 6) show that the vibrations decrease. The frequencies range from 17 to 51 Hz and the vibrations PPV from 0.63 and 2.16 mm/s.

Figure 6. The measurement points at the old building close to Koroska Street.

Concerning German standards for vibration in buildings, the measured values of vibrations before the pavement renewal are above the acceptable level of 3 mm/s for historic buildings (DIN 4150-3 1999). After pavement renewal, the vibration level is reduced and is below the threshold.
