# CHALLENGES TO REDUCE SPEED OF MOTORCYCLES IN STARI LOG CURVES

The present research is about improving Traffic Safety, for motorcyclists from infrastructure point of view, on one of road section for motorcyclists in Slovenia (Stari Log curves).

The research was conducted in 4 phases: (1) Overview of accident data, inspection of signage and markings and hidden speed measurements. (2) Improving road signage according to national regulations (usage of signage which road uses are already familiar with) and to measure the effect with Eye-Tracking system. (3) Additional hidden speed measurements with before / after study. Implementation of new "special" markings, and again evaluation with Eye-Tracking system. (4) Final analysis with matrix of how road (re)design influences drivers (motorcyclists) behaviour regarding speed reduction and their perception of the road (signage and curves).

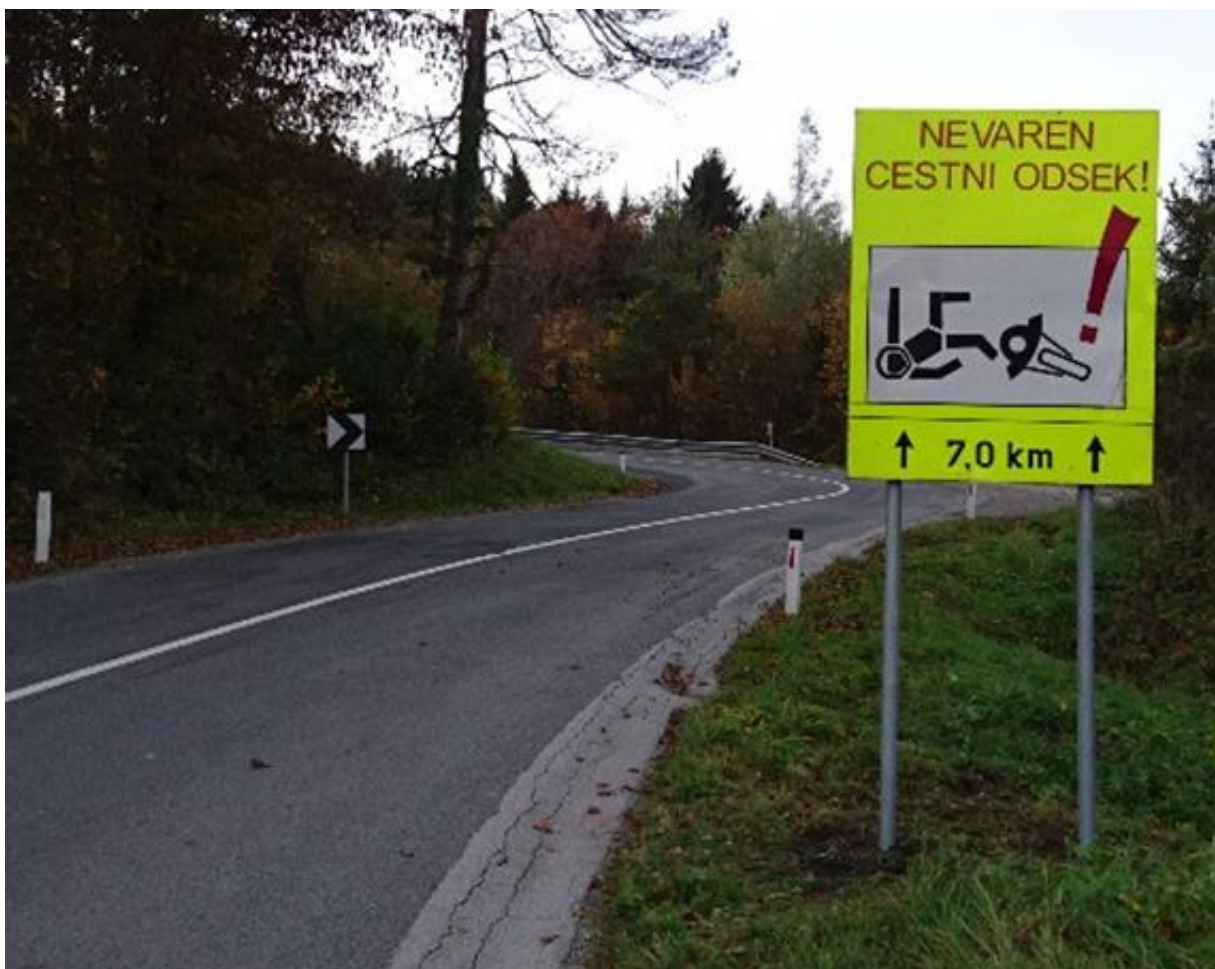
"Figure 1 – Information sign »Dangerous Road Section«"

Road section is also recognised as a motorcycle road, that is why information signs "Dangerous road section" are put in place at several locations (see Figure 1), and local speed limits are posted at more dangerous curves, where curve radius changes more than usual (sharper and/or longer curves).

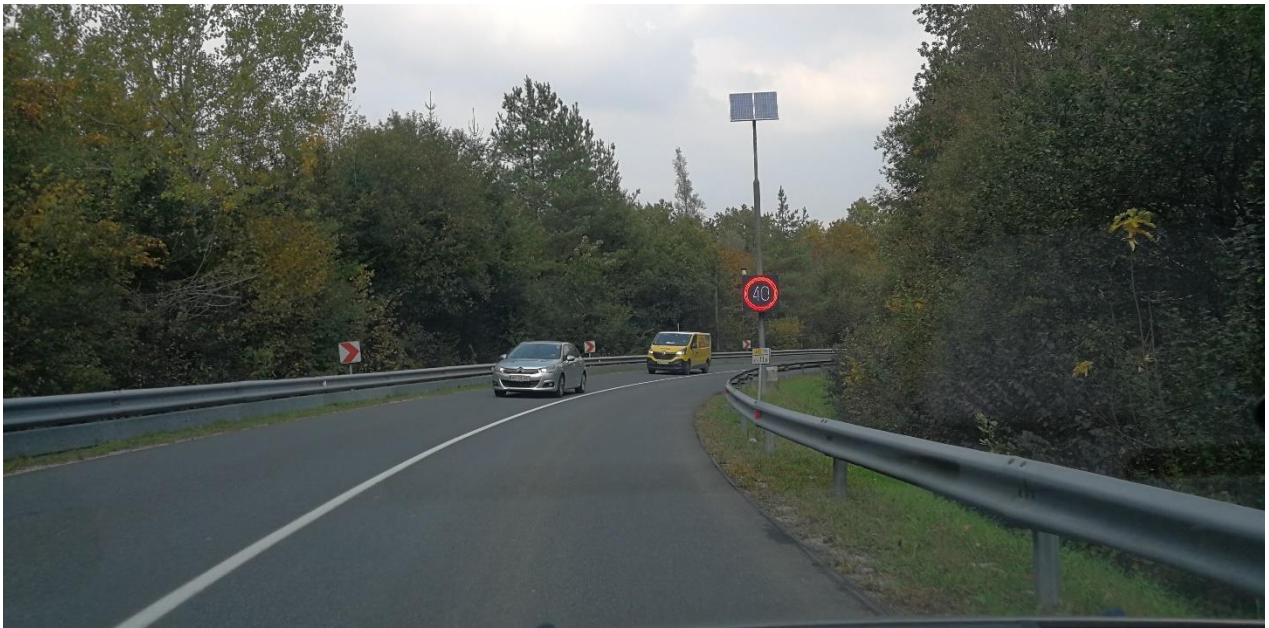
“Figure 2 – LED traffic sign (40 km/h)”

One of these curves are also Stari Log curves between km 10.950 and km 11.130, where speed limit is reduced to 40 km/h, and where additionally LED traffic sign is set up to warn drivers driving with higher speeds that limited to (40 km/h).

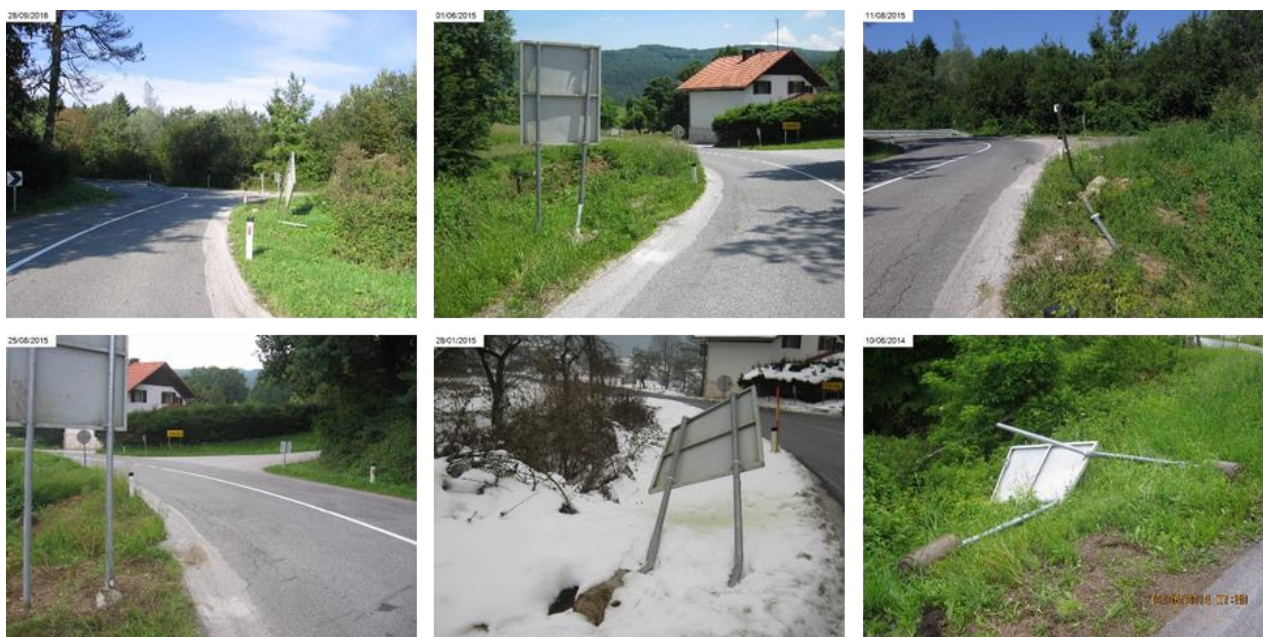
“Figure 5 – Frequented damage of traffic sign”

Beside official accident data, there were several reports from maintenance crew regarding damage (hit and run) of traffic signs, especially the information sign “Dangerous road section” as showed in Figure 5. In addition, scratch marks on road safety barriers prove that more things occur in these curves than official accidents data shows.

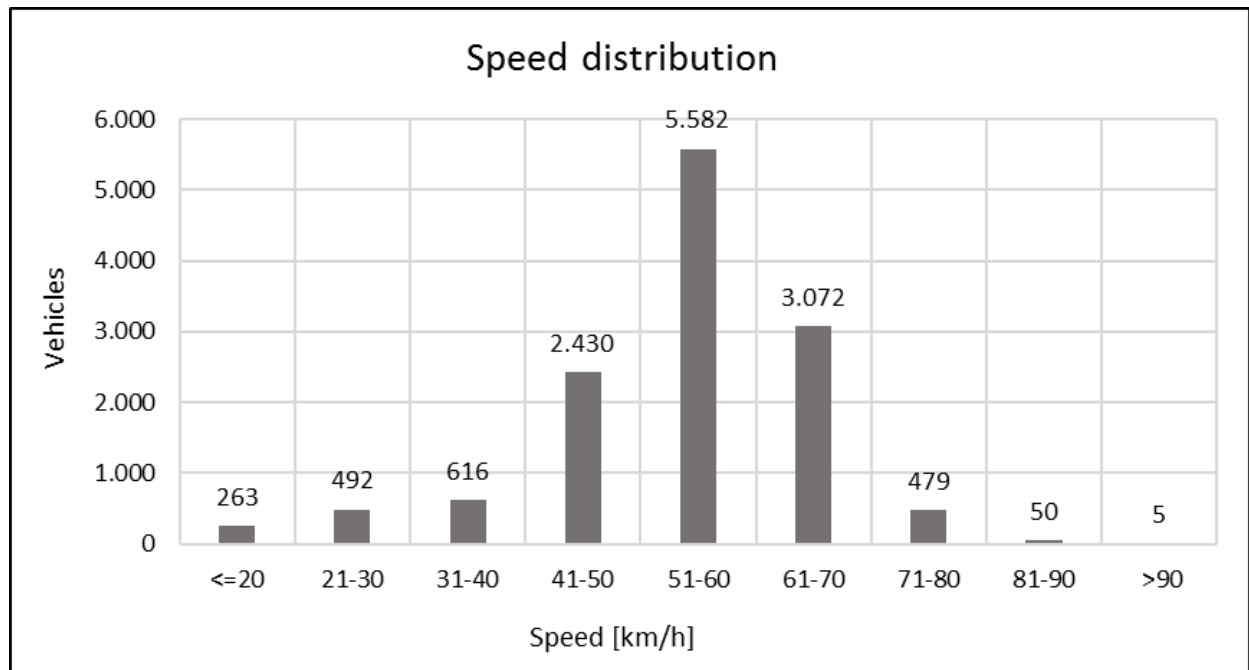
“Figure 7 – Speed distribution from direction A”

From the Table 3 and Figure 7, we can see that majority of vehicles, in direction A, are driving with speeds between 51-60 km/h and 61-70 km/h, which is more than is allowed by the speed limit 40 km/h. That means that 70,74 % of drivers drive over the posted speed limit of 40 km/h.

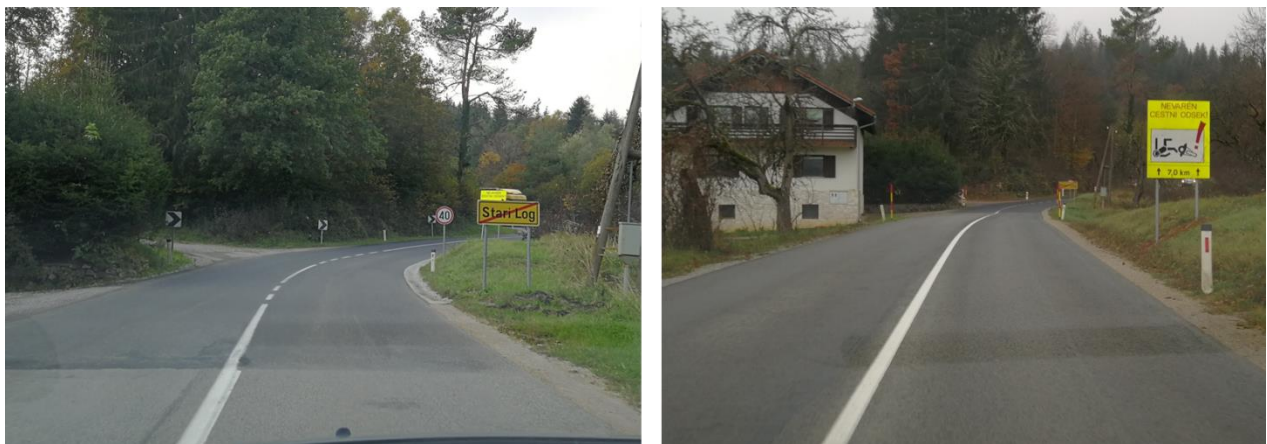
"Figure 9 – Relocation of information sign »Dangerous Road Section«"

First, the information sign "Dangerous Road Section" was relocated, due to many damages in the past on previous location, which was practically in the curve, and because it was partly obstructed by the traffic sign for town Stari Log, and later on with traffic sign for speed limit (40 km/h).

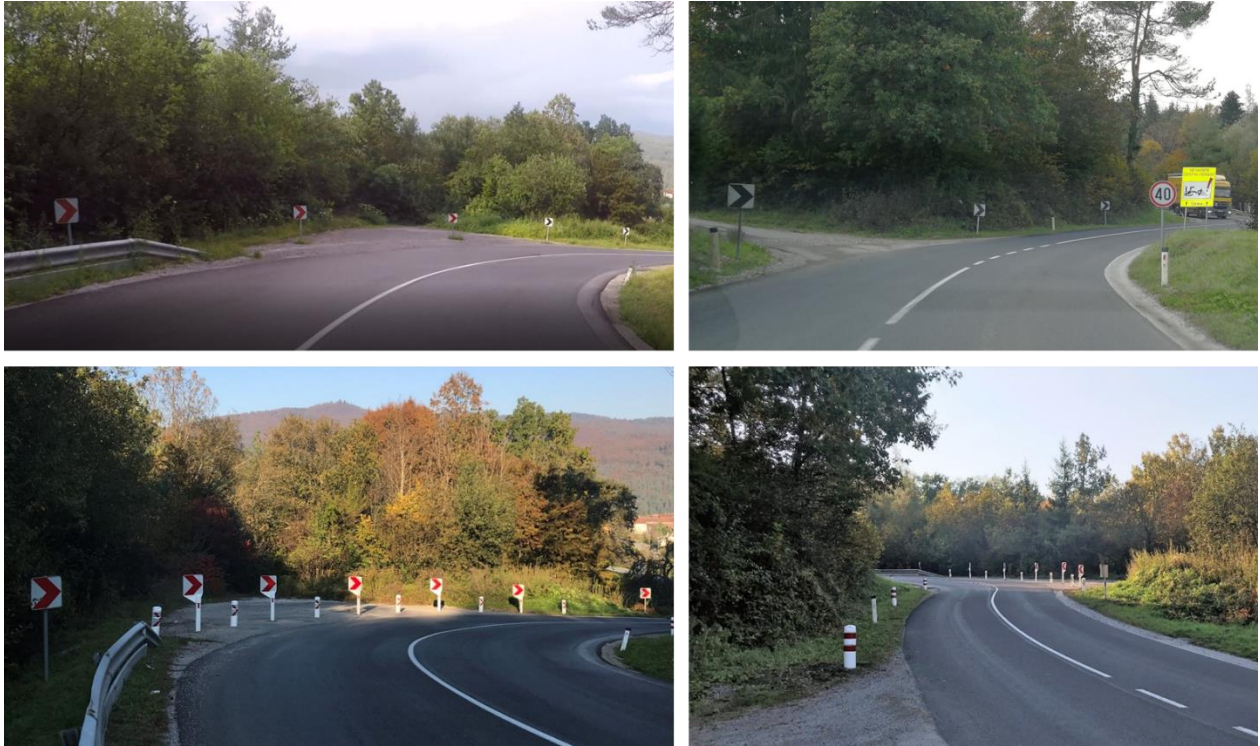
“Figure 10 – Traffic signs (Chevrons and bollards) – before/after”

Secondly, existing traffic signs for guidance true the curves (Chevrons) has been replaced with passive safe and more user-friendly signs (Chevrons) and bollards for guidance true the curves.

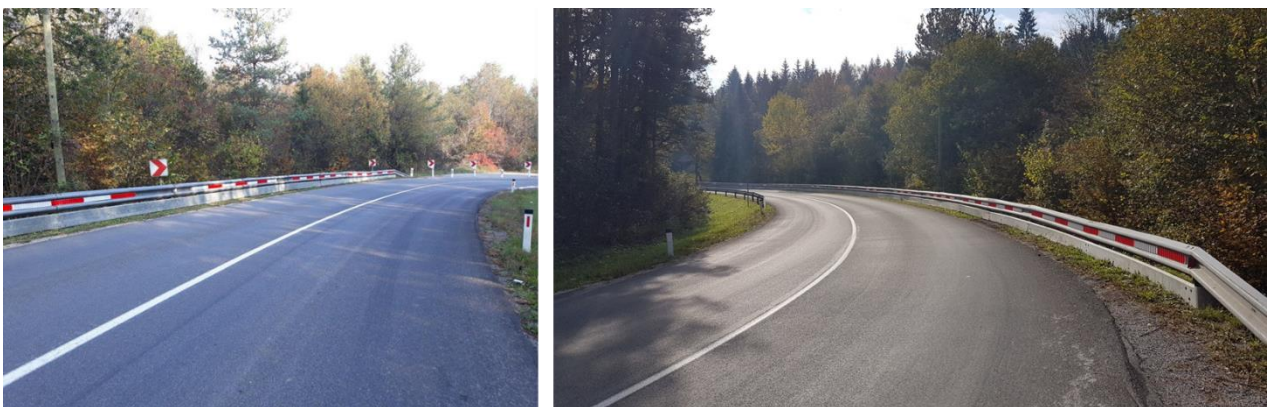
“Figure 11 – Red/white markings on Road Safety Barrier”

Red/white stripes were placed in the groove of road safety barrier at longer curve, as on smaller inner curve red/white markings were set up on the edge of the road. In addition, signs for guidance thru curve (Chevrons) were placed on the bollards on smaller curve.

- red/white elements mounted on a road safety barrier (the outer part of the curve), attracted more views of the drivers, compared to the red/white marking on the edge of the road (the inner part of the curve),

- the installation of additional red/white elements on a road safety barrier had an impact on the speed in the curve, both for cars and single-vehicles (motorcyclists). Speed was reduced in average by 11 %,

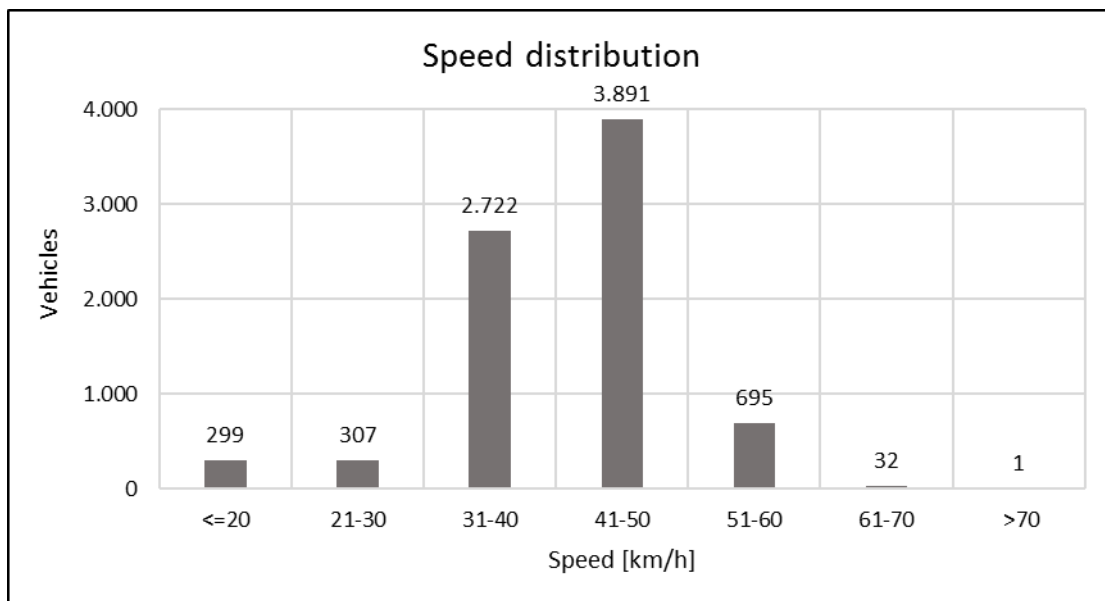
“Figure 14 – Speed distribution from direction B (after)”

As Table 6 and Figure 14 shows, that majority of vehicles, in direction B, are driving with speeds between 41-50 km/h and 31-40 km/h. In this direction higher speeds remain, but extremes are much lower (for both directions). Consequently that means that 58,12 % (before 84,85 %) of drivers are driving over the posted speed limit of 40 km/h.

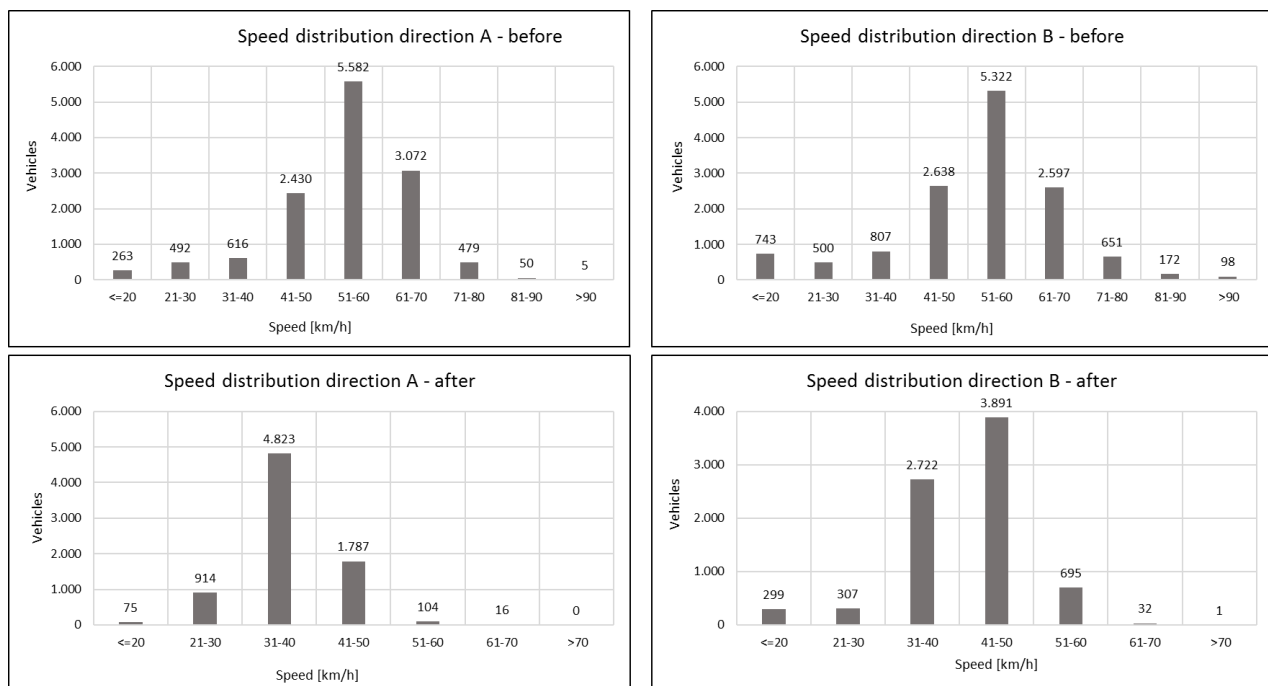
“Figure 15 – Speed distribution from direction A and B (before/after)”

Even though traffic volume has decreased from July to October, as the road has a seasonal meaning, we can see that speeds dropped due to enhanced (pre)warning with traffic signage and with that posted speed limit gain on its credibility.

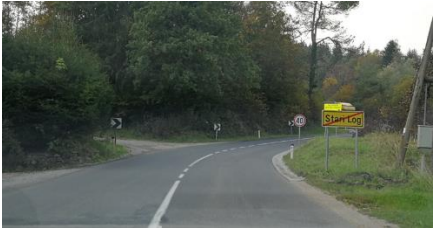
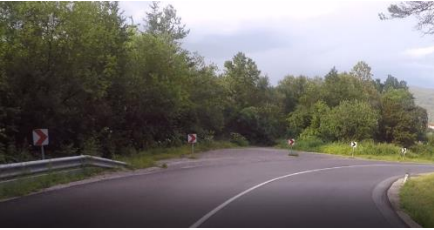
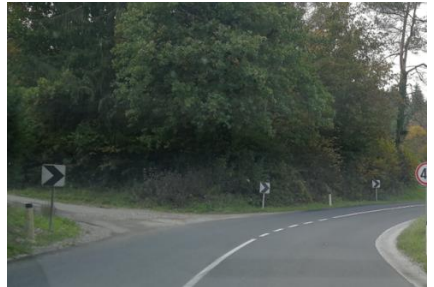
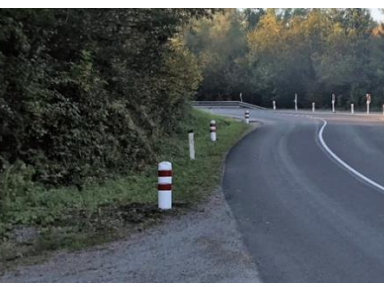
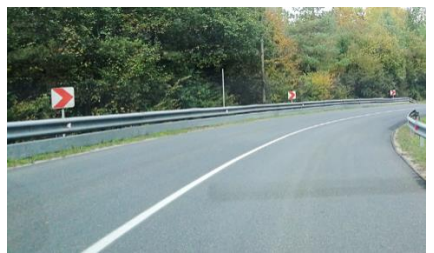
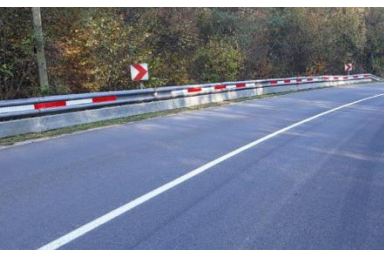
"Figure 16 – Matrix of Eye-Tracking analysis"

Relocation of information sign "Dangerous Road Section"	Important positive impact ↗

Replacement of existing chevron signs with passive safe chevrons and bollards for guidance true the curve	Significant positive impact ↑

Replacement of existing chevron signs with passive safe bollards for guidance true the curve	Important positive impact ↗
2 <sup>nd</sup> phase

<i>Adding red/white elements in the groove of road safety barrier</i>	Important positive impact ↗

<i>Adding red/white markings on the edge of the road</i>	Little positive impact →

Adding chevron signs on the bollards	No impact ↘

Results of Eye-Tracking analyses are shown in matrix in Figure 16.

Based on the conclusion above and matrix of the Eye-Tracking analysis (Figure 16), we can conclude that the interventions performed have had a positive effect on the visual perception and detection of the course of the road.
